From: The Radiographic Section of the Metallotechnical Laboratory, Finnish State Technical Research Institute (Research Engineer: *J.-E. Holmström*, Dipl. Ing.).

## A ROENTGENOLOGICAL STUDY OF INTERNAL DEFECTS IN CHROME-COBALT IMPLANTS AND PARTIAL DENTURES

KEIJO MATILA

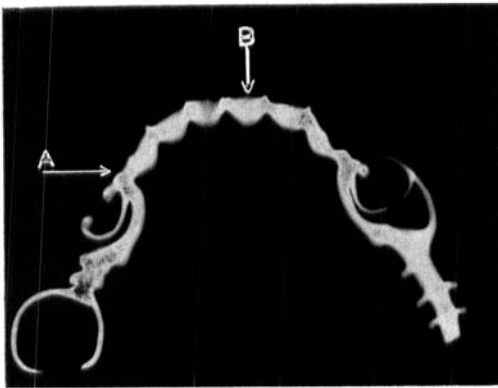
Fig. 1. Crack at site A.

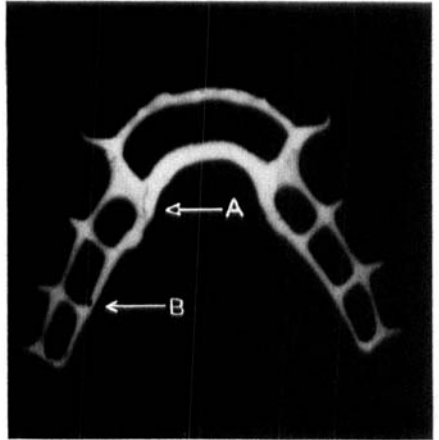
Fig. 2. Crack at site A, "bubble" at site B.

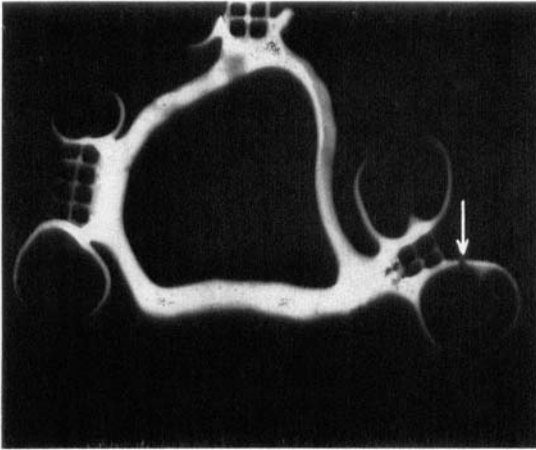
Fig. 3. One "bubble" in the clasp, several at the junction of arm and bar.

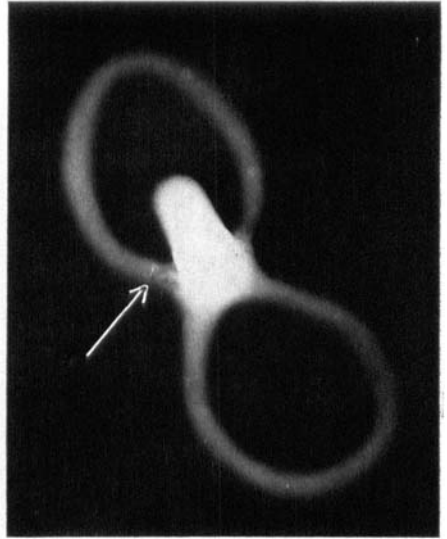
Fig. 4. Implant. Flaw in the casting marked with an arrow.  
Magnification  $\times 5$ .

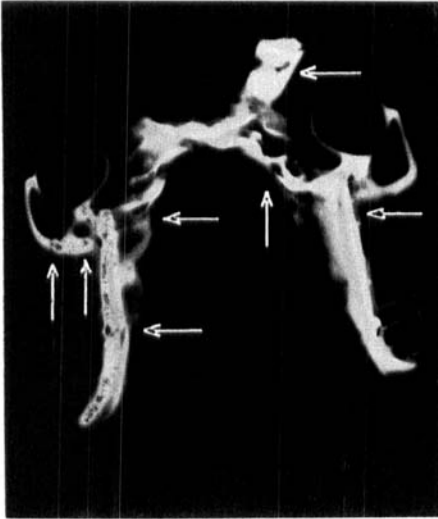
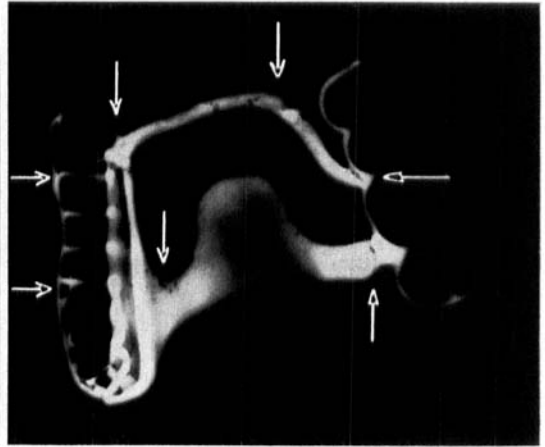
etc., or, in general, any casting flaw liable to weaken the denture to an extent making it susceptible to break under biting pressure. The largest number of such flaws appearing in a single denture was seven (Figs. 5 and 6).

Fig. 5-6. Sites of flaws marked with arrows.

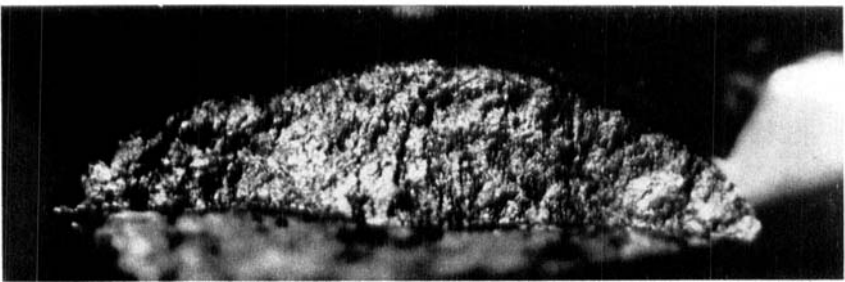
Fig. 7a. Photomicrograph of fracture surface, corresponding to site A in Fig. 1. Magnification x 30. The smooth crystal structure appearing on the surface is due, according to experts, to the effect of hydrogen.

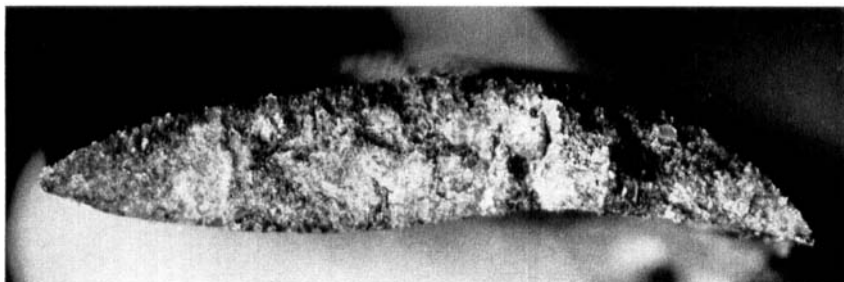
Fig. 7 b. Photomicrograph of fracture surface corresponding to site B in Fig. 1. The crystal structure of the surface is smooth and homogenous in appearance.

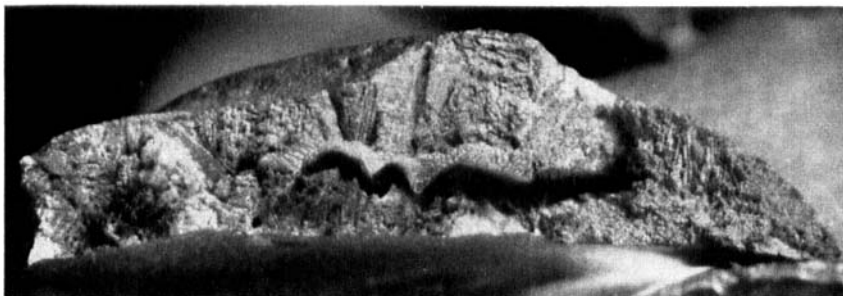
Fig. 8 a. Photomicrograph of crack at site A in Fig. 2.

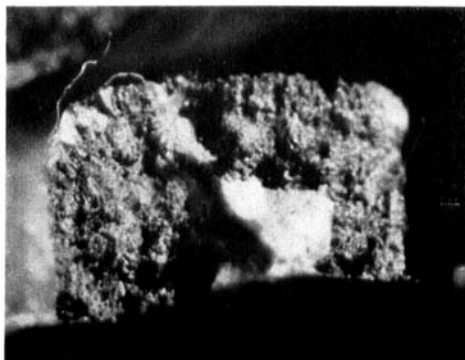
Fig. 8 b. Photomicrograph of site B of portion of bar shown in Fig. 2.

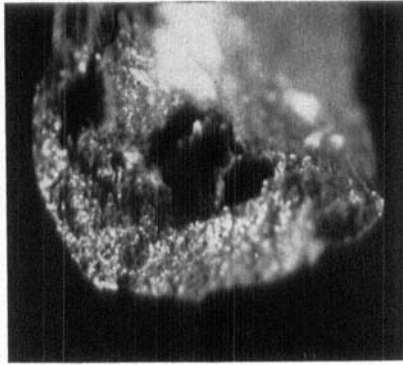
Fig. 9. Photomicrograph of flaw in casting of clasp after being broken (see Fig. 3).

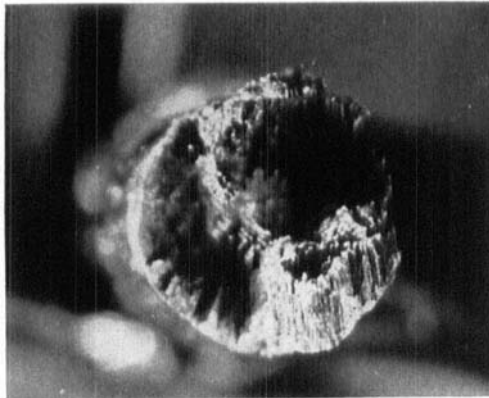
Fig. 10. Photomicrograph of defect in bar of implant, as disclosed by roentgenogram in Fig. 4.

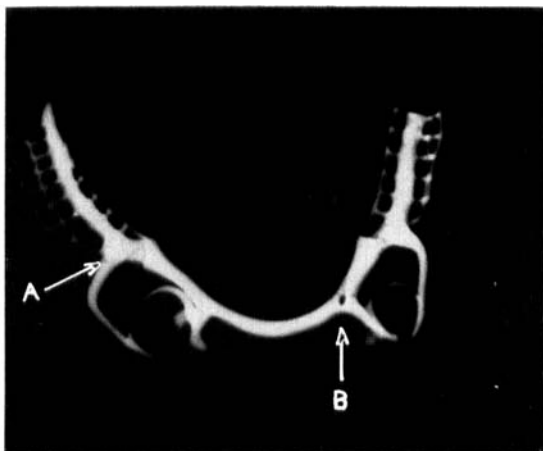
Fig. 11 contains a roentgenogram of one denture which was broken afterwards at the point where flaws were revealed, photomicrographs of the defective surfaces being shown alongside. Further a photograph was taken of the broken denture to demonstrate that the breaches are in the same places as the flaws disclosed by the X-rays.

Fig. 11 a. Roentgenogram of prosthetic bar for lower jaw.

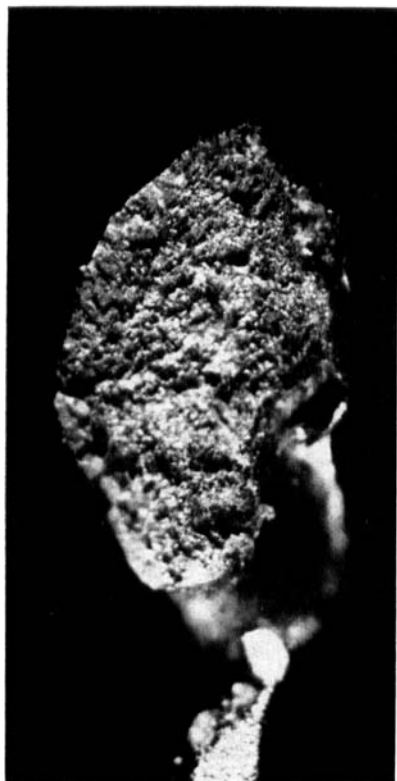
Fig. 11 b. Photomicrograph of the junction of the clasp at site A.  
Crystal structure uneven.

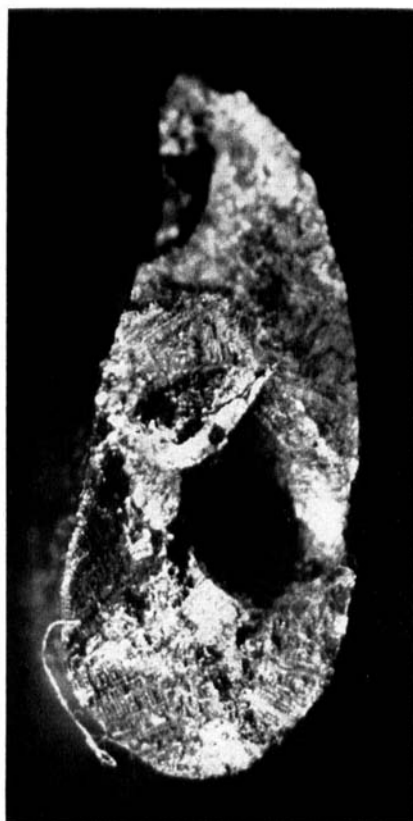
Fig. 11 c. Photomicrograph of site B appearing in roentgenogram.

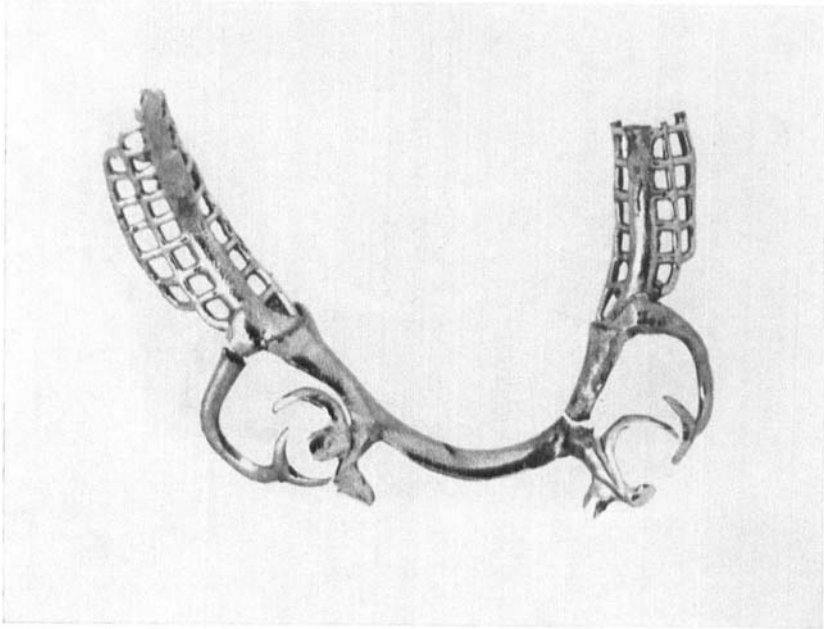
Fig. 11 d. Photograph of bar after being broken.
