From: The Department of Technology, the
Royal Dental College, Copenhagen,
Denmark.

THE MECHANISM OF MARGINAL FRACTURE OF AMALGAM FILLINGS

KNUD DREYER JØRGENSEN

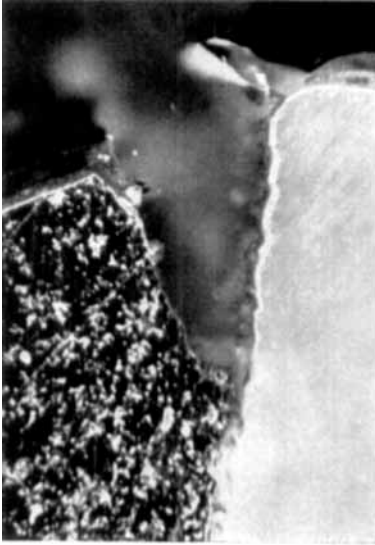
Fig. 2. p-type fracture in an occlusal filling. Note the slit between enamel and amalgam and the oblique surface of fracture, which meets the enamel surface to form a narrow V-shaped groove along the filling margin.

Leitz Ultropak, 90 ×.

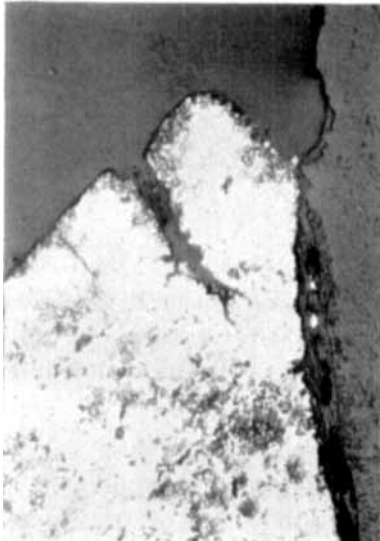
Fig. 4. p-type fractures in an occlusal filling. A piece of the margin is partially broken off and pressed against the enamel surface.

Leitz Opak-illuminator, 90 ×.

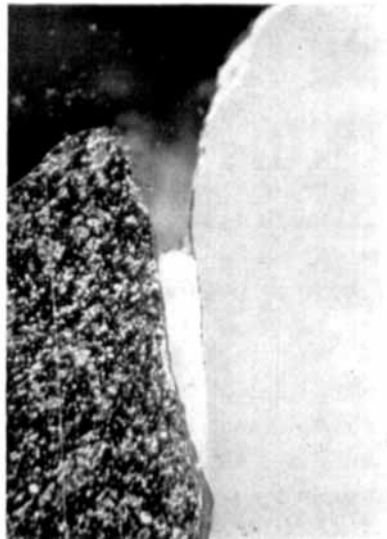
Fig. 19. As Fig. 14.

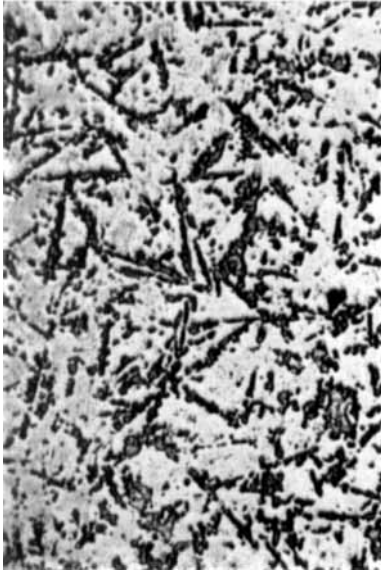
Fig. 23. γ_2 -phase in silver amalgam with a mercury content of 54 % and of 39 %. Leitz Opak-illuminator. 90 \times and 125 \times respectively.

2. In amalgam surfaces which have been polished with a relatively mild abrasive (such as diatomaceous earth) the γ_2 -phase appears as shallow depressions in the otherwise flat surface (Figure 23). The cause of this is probably the difference in hardness between the three components of the set amalgam (γ_2 is by far the softest). In a number of the metallographically examined amalgam fillings it was possible to demonstrate corrosion attacks with partial loss of substance on the so identified γ_2 -phase. Corrosion with loss of substance could not be shown on either the γ -phase or the γ_1 -phase (in specimens prepared as described, the γ -phase often appears as almost black grains when studied by Leitz Ultropak technique).

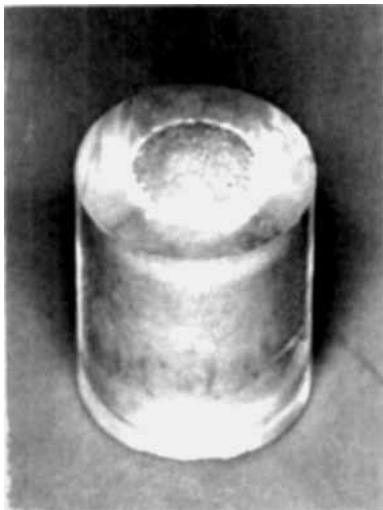
Fig. 26. Corrosion due to the presence of a concentration cell element between the free surface of amalgam and the surface against a glass tube. $3 \times$.

(c). Specimens of amalgam condensed in glass tubes (inside diameter 6 mm, length 15 mm) showed after two months in a 1 % NaCl solution at 37° considerable amounts of corrosion deposits on the outer surface of the amalgam margin (Figure 26). The amalgam showed clear traces of solution in the slit between glass tube and amalgam, which in this case represented the anode in the cell. Although the amalgam displayed great expansion (delayed expansion) the electrolyte was able to penetrate between amalgam and glass tube owing to the poor adaptability of the amalgam with an R_a value of 3—5 μ (cf. *Jørgensen*, 1964).

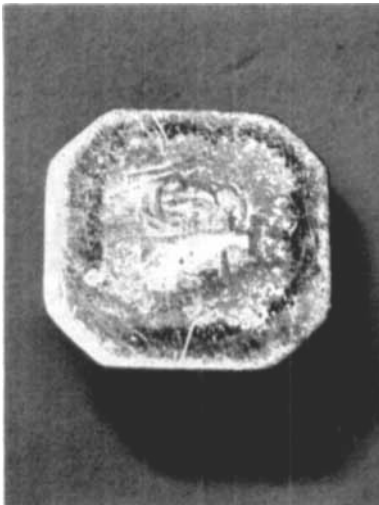
Fig. 28. Gold plate with corrosion products and central discoloration by mercury liberated by the amalgam corrosion. 4 \times .

(a). When amalgam is brought into contact with a plate of dental gold alloy in a 1 % NaCl solution (the experiments were made at 37° C) a very severe corrosion occurs, which after a few days results in formation of substantial amounts of corro-

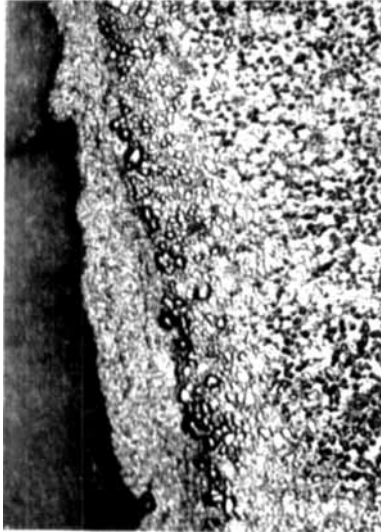
Fig. 30. Drops of free mercury along the margin of a section through a corroded amalgam filling. 90 \times .

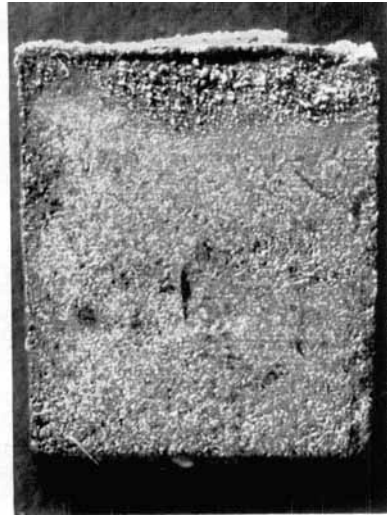
Fig. 36. Corrosion experiment with amalgam with uneven mercury distribution. The upper end with most mercury is anodic and presents gross corrosion; the remaining part of the amalgam is cathodic and free from corrosion, 12 \times .

tively low mercury content. This latter condition was demonstrated by placing amalgam specimens prepared by hand condensation, but without removal of excess mercury, in a 1 % NaCl solution at 37° C for about 14 days. The last condensed, most mercury-rich parts of the specimens were in all cases covered with a thick layer of corrosion products, while the other part with less mercury showed no signs of corrosion*) (Figure 36).

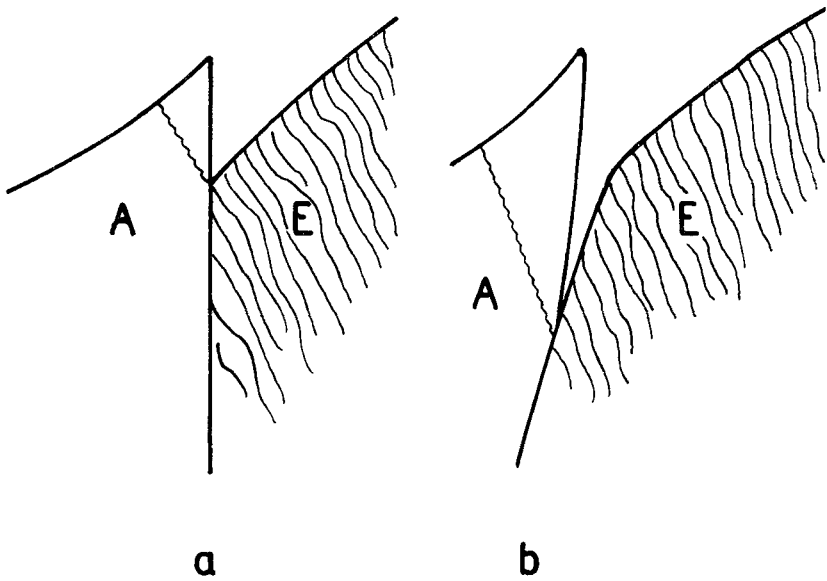
Fig. 37. Marginal discrepancy of amalgam margin as a result of delayed expansion. Any marginal fracture of the p-type will occur roughly corresponding to the serrated line.

The consequences of this expansion in terms of marginal precision were studied on about 50 experimental fillings in extracted teeth. The fillings were prepared from an alloy with 2 % Zn, and they were contaminated with a 1 % NaCl solution. Teeth with fillings were stored in a 1 % NaCl solution at 37° C for 3—24 months and then studied under the microscope. It was found that the marginal defects could be referred to two principal types, a and b, Figure 37. Type a occurred whenever the cavity wall and the expansion direction of the amalgam out of the cavity were parallel or convergent, while type b occurred in connection with divergence of cavity wall and expansion direction. Both types were observed in occlusal as well as peripheral fillings.

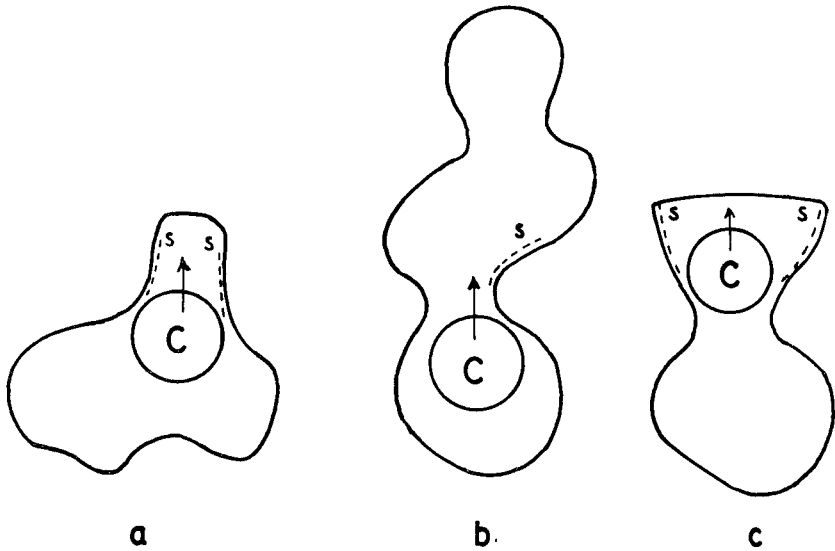
Fig. 39. Examples of displacement of amalgam in different type of cavities under vertical pressure by the condenser *c*. The amalgam is displaced *e. g.* in the direction of the arrow, so that slits corresponding to the areas *s* may occur between cavity wall and already condensed amalgam.

In the final condensation of amalgam fillings the areas already condensed may rather easily be displaced. Three examples in Figure 39 show how such displacement may give rise to slits of quite appreciable size between cavity and condensed filling: a) is a Class I filling in an upper molar; the condenser, *c*, is forcing the amalgam out into the lingual extension, so that slits as indicated by the dotted lines, *s*, are apt to occur. b) represents a Class I filling in a lower molar, where the condenser is pressing the amalgam through an isthmus toward a wider space of the cavity; the consequent shifting of the amalgam already in place will give a slit at *s*. c) shows the contour of a proximo-occlusal filling seen from the occlusal surface. Insufficient matrix application may easily result in outward displacement of

the amalgam into the interproximal space, and slits at *s* will ensue.
