Ductility of a dental Ag-Pd-Cu-Au alloy

Syverud M, Herø H. Ductility of a dental Ag-Pd-Cu-Au alloy. *Acta Odontol Scand* 1984;42:47-52. Oslo. ISSN 0001-6357.

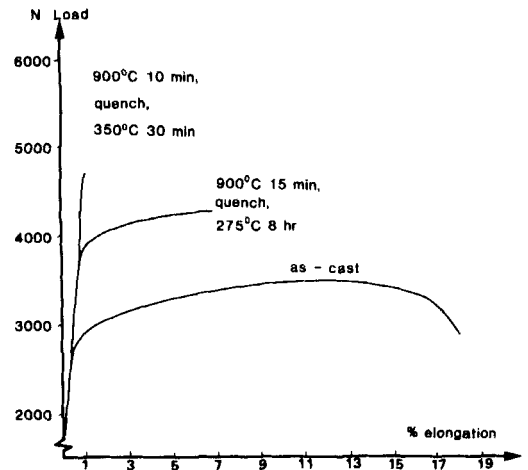
Fig. 1. Tensile curves for the three investigated conditions of the alloy.

The mechanical properties of the tensile tests are given in Table 1. It can be seen that age-hardening causes a significant increase in yield strength, ultimate tensile strength, and hardness but at the same time a lowering of the total elongation. These differences in properties are illustrated in Fig. 1 by a representative load-elongation curve from each group of materials. Particularly, the highest

of the three tensile specimens there was hardly any plastic deformation at all before fracture (Table 1, Fig. 1). The SEM micrograph with a two-face view of the fractured specimen (Fig. 8) clearly demonstrates that the failure occurs along the grain boundaries. The specimen was quite coarse-grained (240 μm), as was all the examined material after annealing at 900°C. The polished and etched section in Fig. 8 indicates a reaction zone along and adjacent to the grain boundaries, which is even more clearly illustrated in Fig. 4a. At a higher magnification precipitated particles can be observed (Fig. 4b). It is well known that such particles can make the material prone to intergranular fracture. The structure of the discontinuous particles at grain boundaries after annealing at 350°C in an alloy similar to the present one has previously been found by transmission electron microscopy studies to be complex (1). These investigations indicated that the particles consisted of alternating lamellae of a CsCl type of structure and Ag-rich f.c.c. material. Zones with particles of this kind have previously been reported by Ohta et al. (2) at temperatures above 275°C and up to 375°C. The lowest temperature for their occurrence depended on alloy composition and grain size. Precipitation of hardening particles (PdCu-ordered f.c.t.) took place at a wider temperature range in the interior of the grains. Their findings are in accordance with the present observations, as age-hardening at 275°C was found to cause a much narrower reaction zone along the grain boundaries (Fig. 3) and a more ductile-like appearance of the fracture surface with tendencies to dimples (Fig. 7).

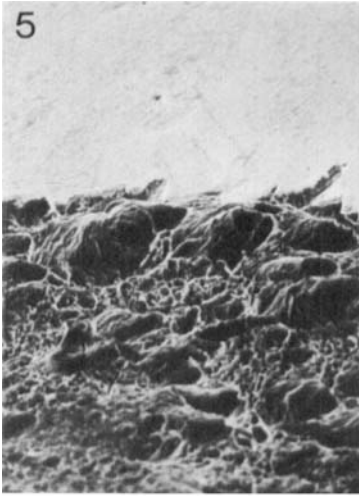
Figs. 5, 6, 7, and 8. SEM two-face views of fractured tensile samples, showing both the polished/etched longitudinal cross-section and the fracture surface.

Fig. 5. As-cast. ($\times 500$.)

The as-cast material had an even weaker mechanical strength with $\sigma_{0.2} = 403 \text{ MN}/\text{m}^2$ and at the same time a high total elongation of 20% (Table 1) and a fracture surface with many dimples (Fig. 5), which is normally associated with a ductile failure. The uniform

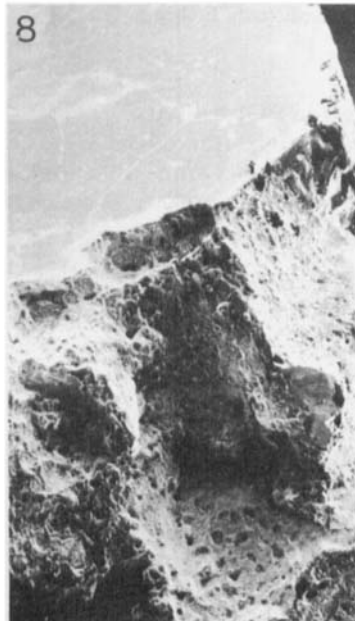
Fig. 8. Aged at 350°C for 30 min. ($\times 100$.)

intergranular fracture (Fig. 6) were observed even in the quenched specimens after annealing at 900°C in quartz ampullae and before aging. Small particles have been precipitated along grain boundaries either at 900°C or during quenching, as can be seen on the polished section in Fig. 6. It is well known that even thin films may cause intergranular fracture and brittleness. It can be suggested that upon subsequent aging at 275°C the improved ductility is due to an agglomeration of the initial film or particles, in addition to further precipitation and growth of particles. At 350°C the amount of grain boundary particles becomes so large that the ductility decreases again. Both the polished sections and the fracture surfaces in Figs. 6, 7, and 8 support this suggestion.
